Your Inspection Report

111 Example Street
Ottawa, ON

Saturday, June 12, 2010

RE: Report No. 1058, v.2
111 Example Street
Ottawa, ON

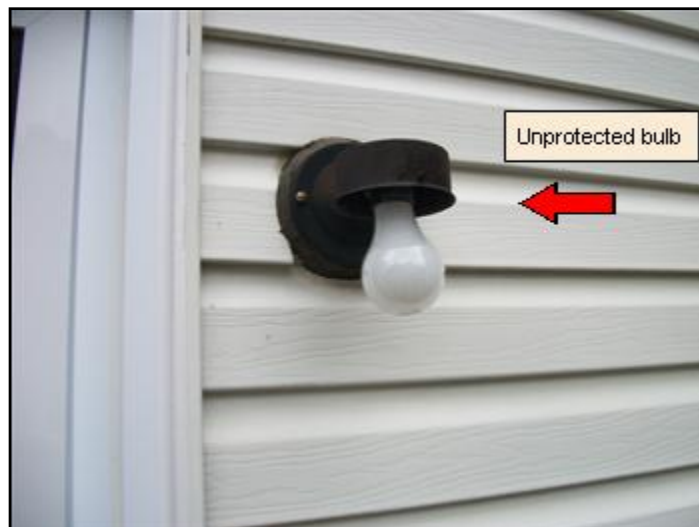
1.

This bulb requires a cover, or should be replaced with a proper exterior fixture.

Implication(s): Electric shock | Fire hazard

Task: Repair or replace

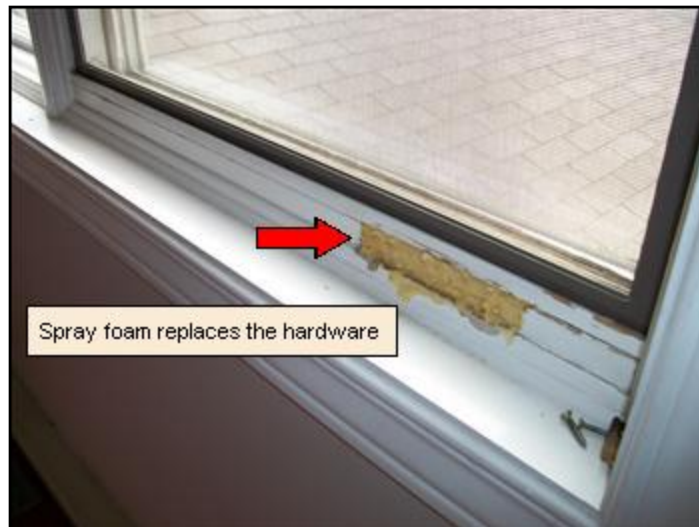
2. Location of missing hardware

The hardware has been removed, and spray foam seals the window shut.

Implication(s): System inoperative or difficult to operate

Task: Replace

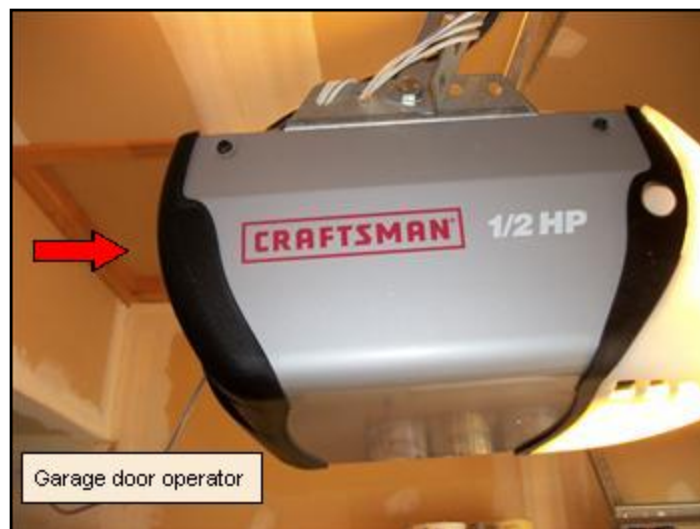
3. Garage door operator

The garage door operator requires adjustment to prevent injury by crushing.

Implication(s): Physical injury

Task: Correct

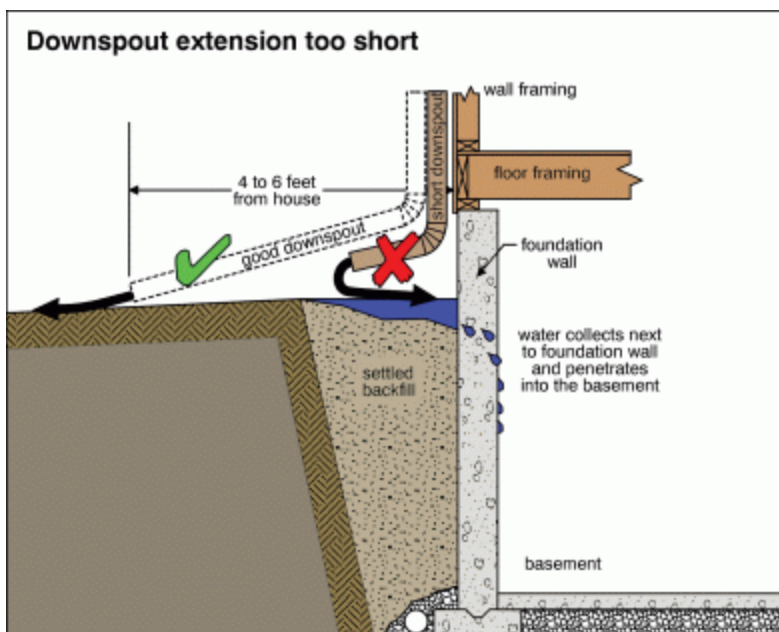
Condition: • Should discharge 6ft. from home

Implication(s): Chance of water damage to contents, finishes and/or structure

Downspout extension too short

Task: Improve

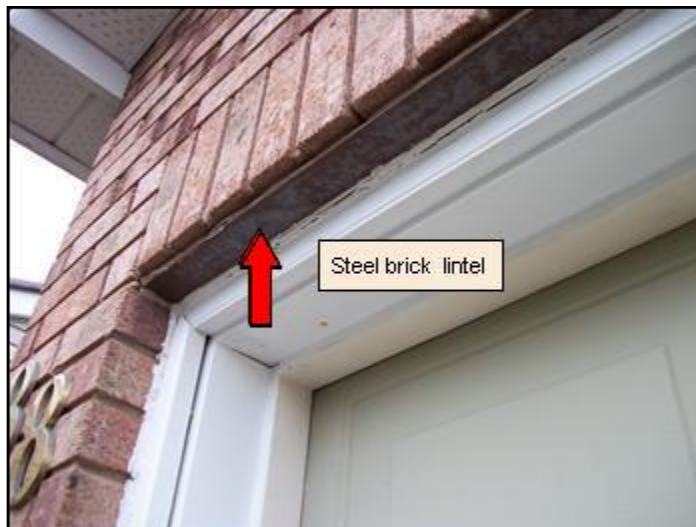
4.

Condition: • The steel lintels above the windows are showing signs of rust and should be repainted with a metal paint. It is recommended that the brick lintels be inspected and painted with a rust resistant paint.

Implication(s): Rust staining from dripping water

Task: Protect

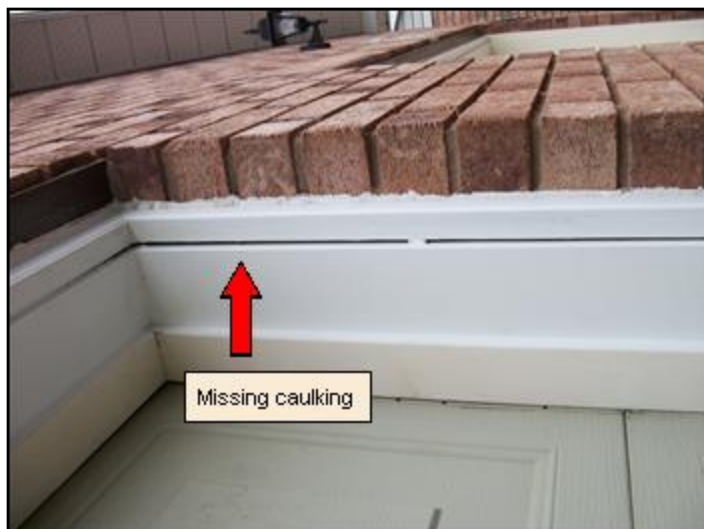
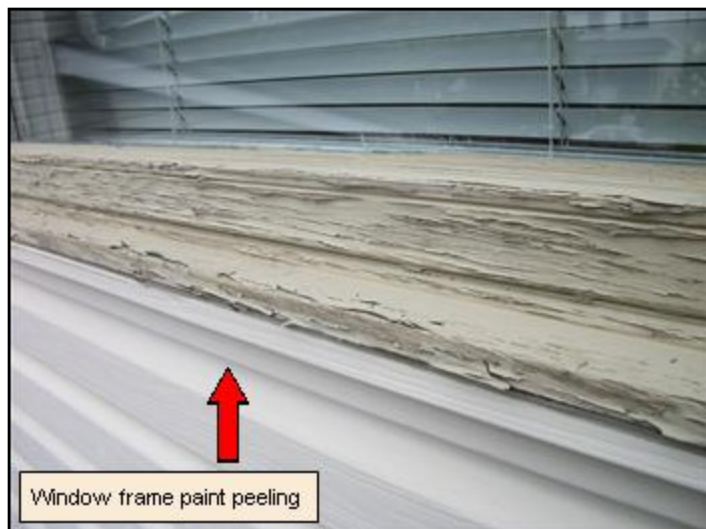
The exterior wood trim requires service: scraping, priming, caulking and application of two coats of premium latex paint.

Implication(s): Chance of damage to finishes and structure | Material deterioration

Task: Repair on ongoing basis

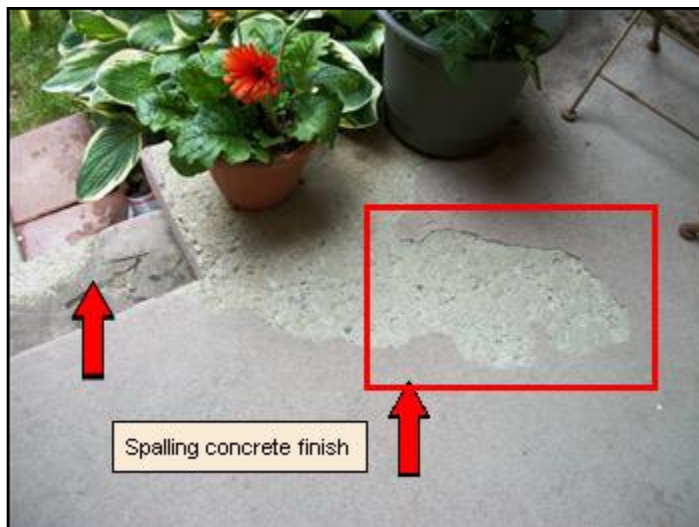
7.

The concrete coating on the front porch has failed and is spalling. This is a common problem with these coatings; proper cleaning and following the manufacturer's instruction is essential for good results.

Implication(s): Cosmetic defects | Material deterioration

Task: Correct

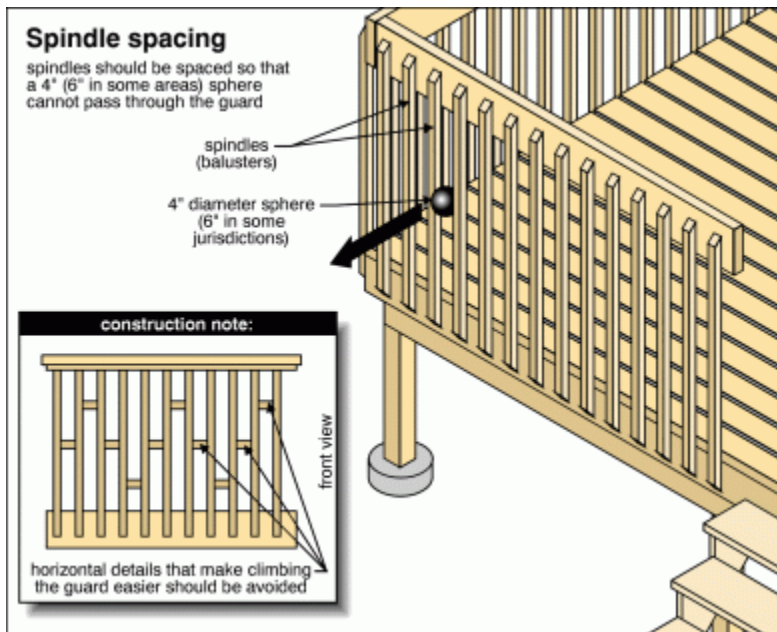
Condition: • [Spindles too far apart](#)

The guardrail on the rear deck is not functional: it is not stable and the spacing is too great.

Implication(s): Fall hazard

Task: Correct

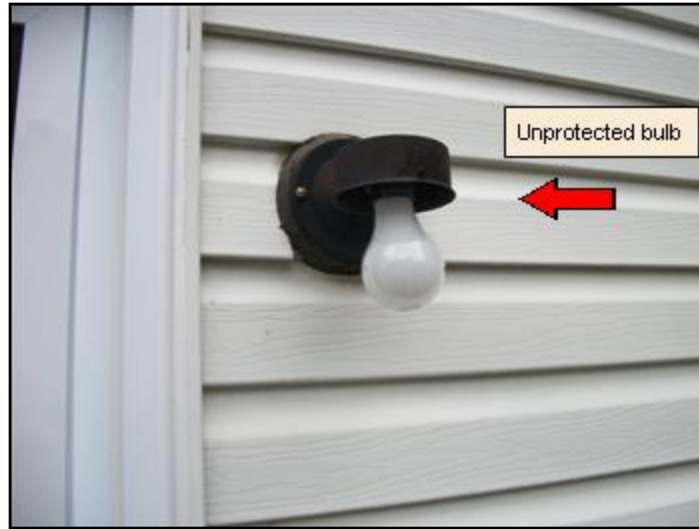
9.

This bulb requires a cover, or should be replaced with a proper exterior fixture.

Implication(s): Electric shock | Fire hazard

Task: Repair or replace

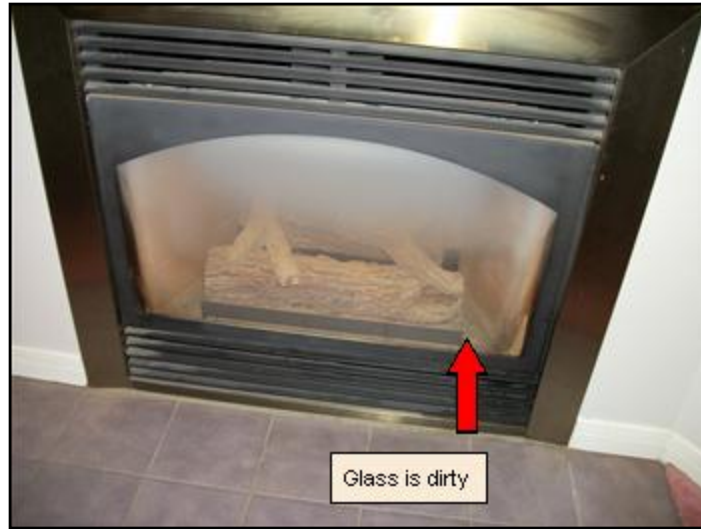
12.

Condition: • The glass is dirty and requires cleaning, and the area under the unit should be vacuumed.

Implication(s): Poor view of the flame.

Task: Clean

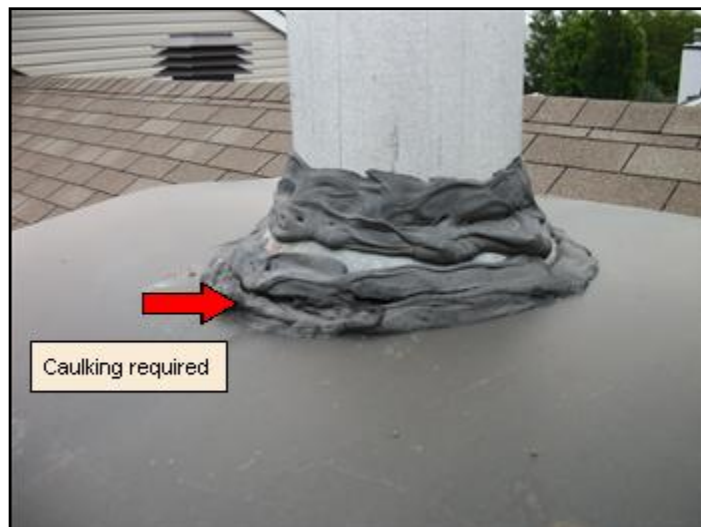
13.

Condition: • The caulking at the junction between the chimney cap and flue flashing requires caulking

Implication(s): Water infiltration, causing damage to contents and structure.

Task: Correct

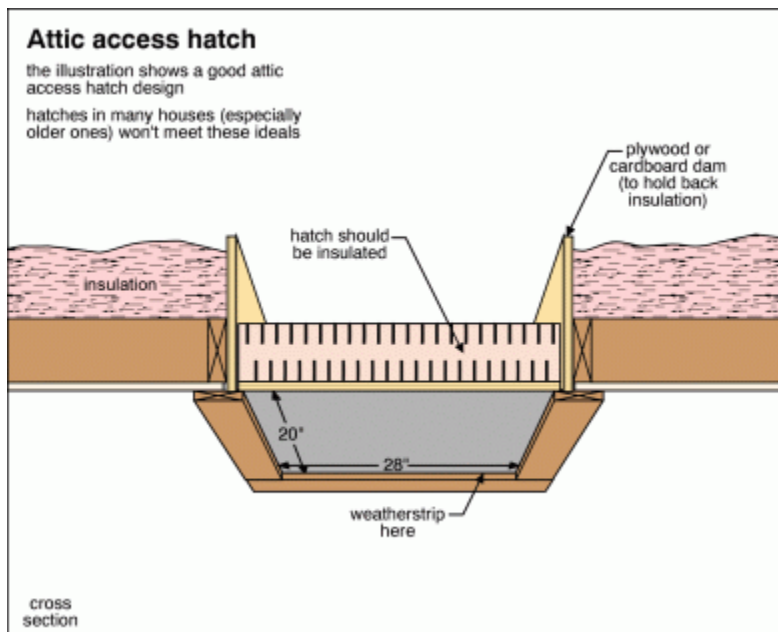
- Condition: • [Not weatherstripped](#)

The foam weatherstrip on the attic hatch required replacement

Implication(s): Chance of condensation damage to finishes and/or structure | Increased heating and cooling costs

Task: Replace

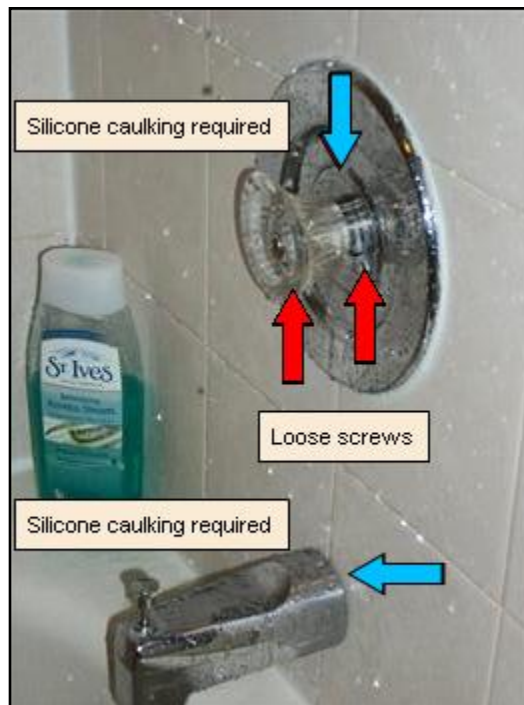
20.

Condition: • [Loose](#)

The faucet plate screws should be tightened and silicone caulking should be applied.

Implication(s): Equipment failure

Task: Correct

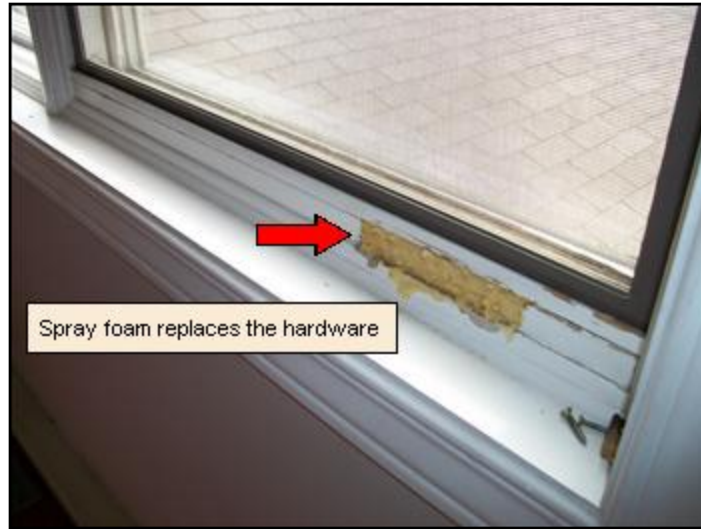
23. Location of missing hardware

The hardware has been removed, and spray foam seals the window shut.

Implication(s): System inoperative or difficult to operate

Task: Replace

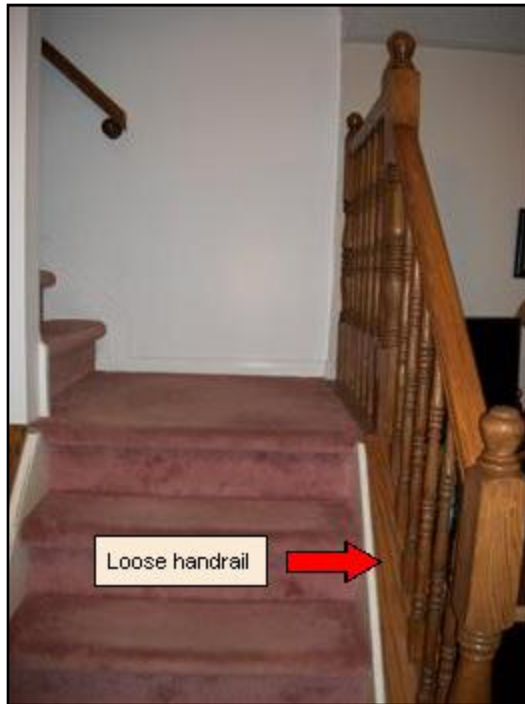
24.

The newel post at the bottom of the staircase leading to the basement is loose and should be repaired ASAP.

Implication(s): Fall hazard

Task: Correct

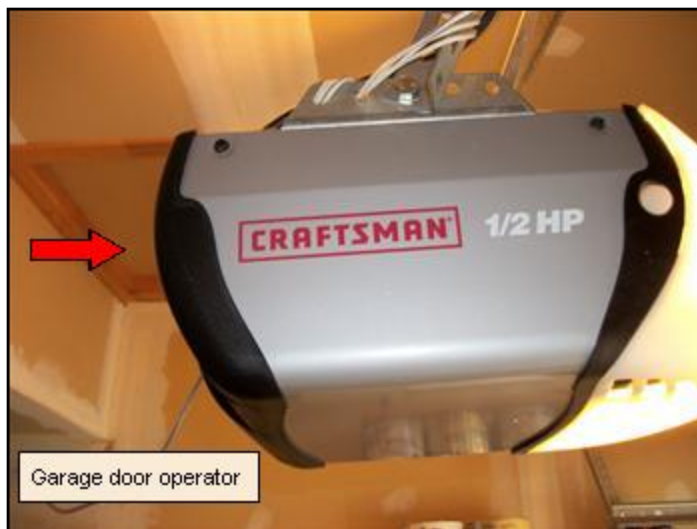
25. Garage door operator

The garage door operator requires adjustment to prevent injury by crushing.

Implication(s): Physical injury

Task: Correct
