Your Inspection Report

111 Example Street
Ottawa, ON

Saturday, June 12, 2010

RE: Report No. 1058, v.2
111 Example Street
Ottawa, ON

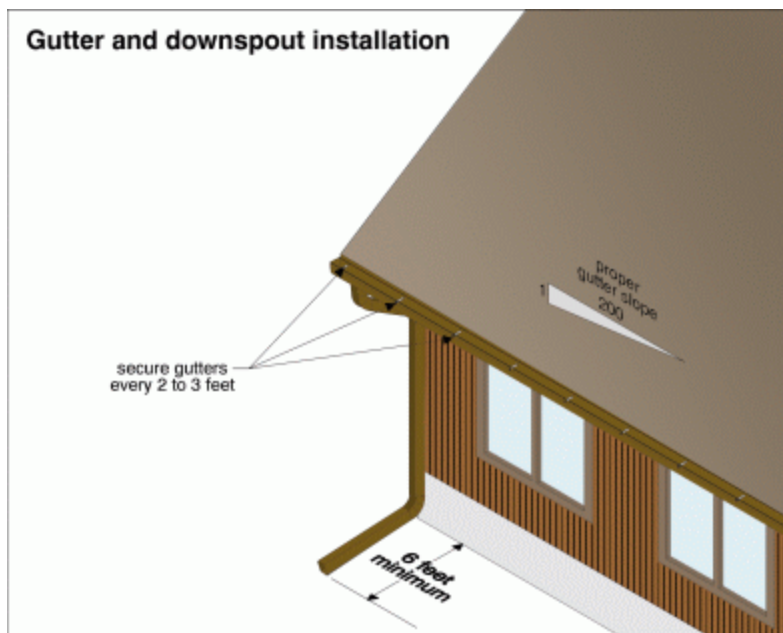
Gutter and downspout installation

Condition: • Should discharge 6ft. from home

Implication(s): Chance of water damage to contents, finishes and/or structure

Downspout extension too short

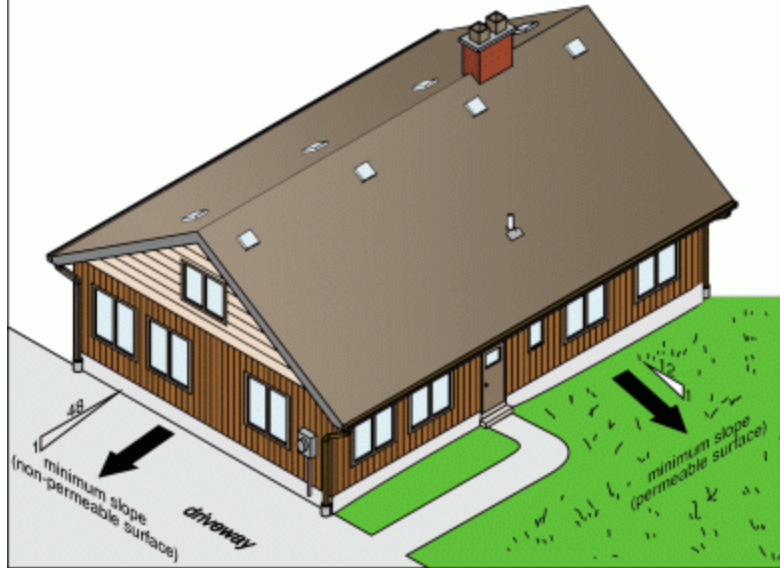
Recommended grading slopes

Condition: • [Improper slope or drainage](#)

The soil should be graded away from the building to reduce water build up at the foundation wall.

Implication(s): Chance of water damage to contents, finishes and/or structure

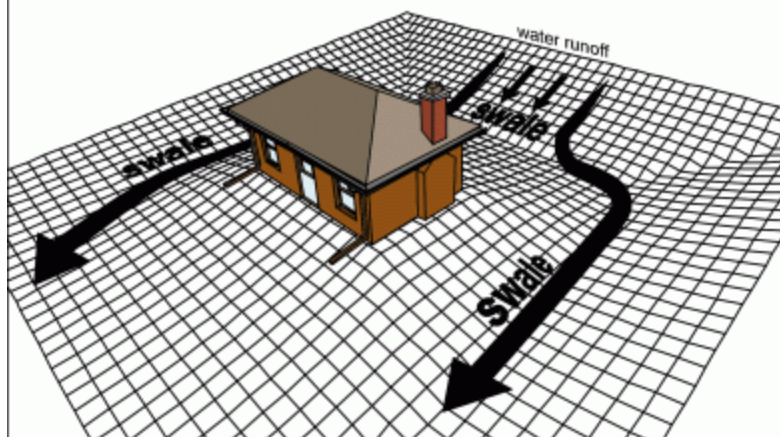
Swales

when the overall lot drainage is toward the house, swales can be used to direct surface water away from the foundation

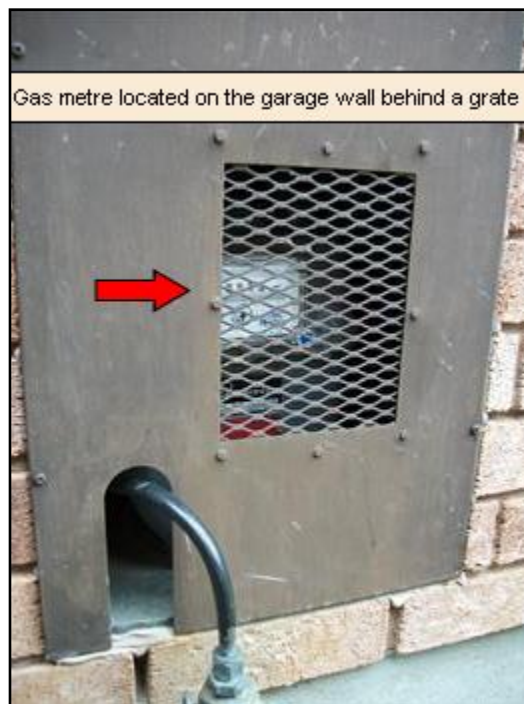
10.

The meter and shut off valve are located behind an access panel on the garage wall near the front door.

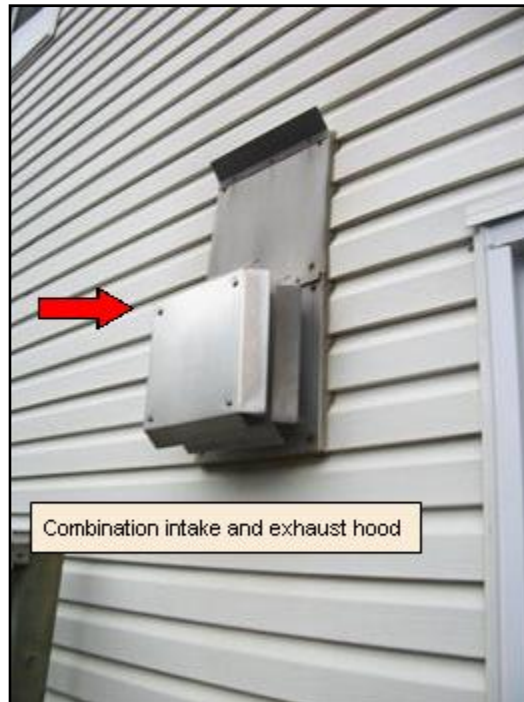
11.

This fireplace uses a combination intake/ exhaust rear wall hood. The metal instruction card is located under the unit. A wall mounted toggle switch controls the fireplace .

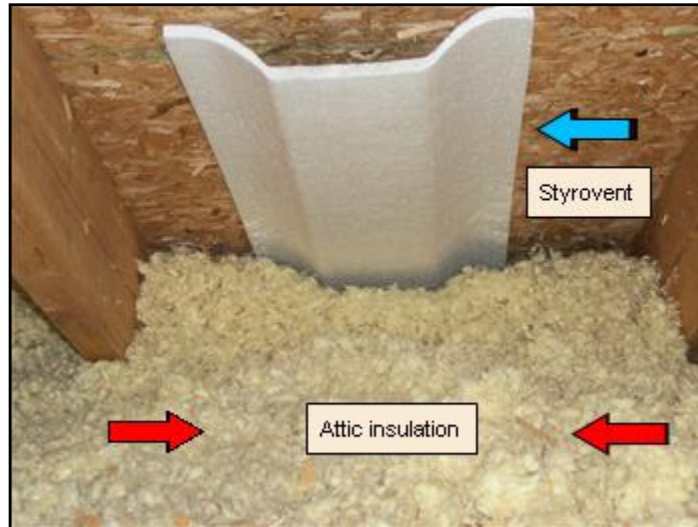
14. Attic insulation

The styrovent keeps the blown insulation from blocking the venting through the soffit.

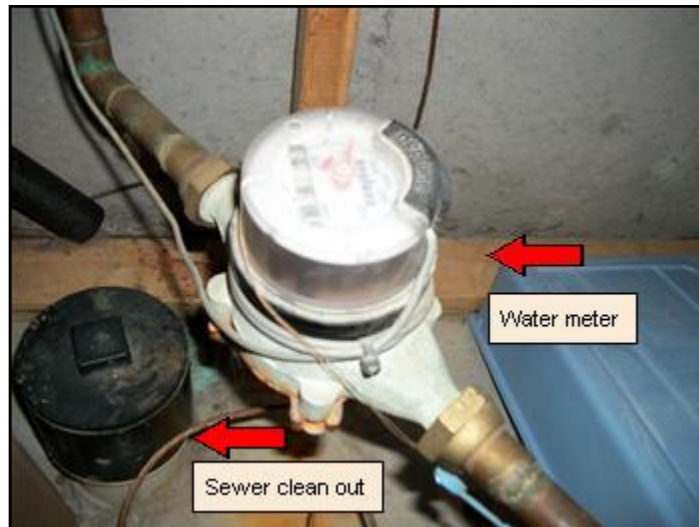
18. Water meter with sewer clean out

The water meter is located at the front of the basement.

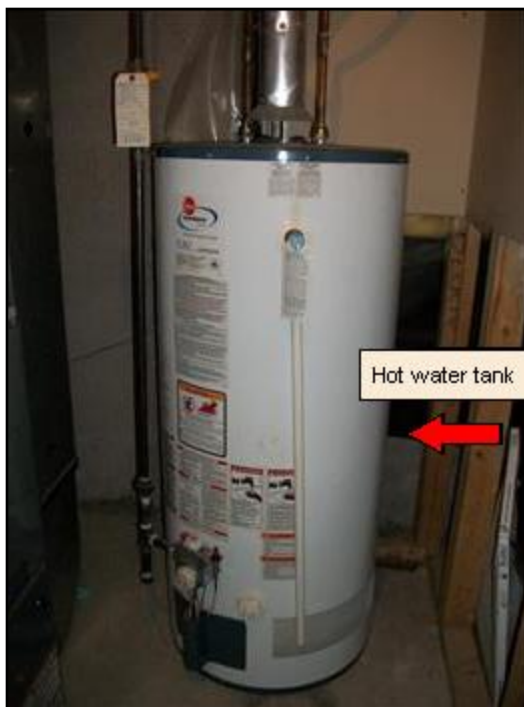
19.

The hot water tank is located next to the furnace.
